Instrument Inspection System

Preventing Healthcare Associated Infections

ARE YOUR INSTRUMENTS PATIENT READY?

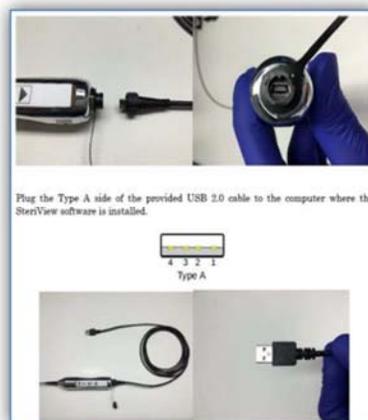
Computer System

- The SteriCam comes with SteriView's proprietary software loaded on a Surface Pro Laptop
- Images and video can be taken from either the handle or from the touchscreen laptop
- All images and videos can be cataloged by scope with references images
- All images and videos are auto date and timed stamped
- The MIC connection is via standard USB
